**Flood Control Project Maintenance
Levee Inspections**
LMA District Cover Sheet
Spring 2017 Levee Inspection Results

American River Flood Control District

Spring 2017 Levee Inspection Results

Waterway			Bank	Unit Miles
Unit No. 01 Arcade Creek			Left	2.08
	Spring (March - May)	Summer (June - August)	(September - November) Fall	Winter (December - February)
Unit Maintenance Rating (Fall Only)				
Date of Inspection	3/15/2017 - 5/3/2017			
DWR Inspector	Maksim Khashchuk			
Accompanied By	Ross Kawamura ARFCD

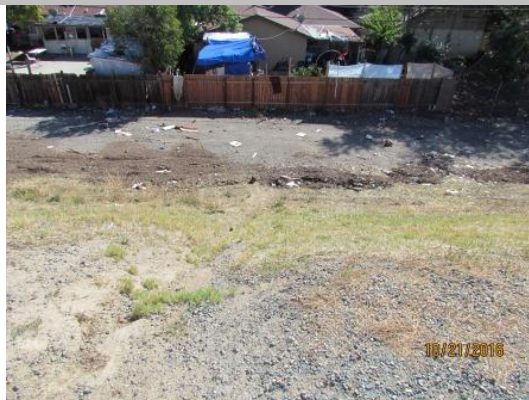
Photo 1 of 2 : SP_2017_NA0001_51_81_20170313_00048.jpg

LM Start	0.46	Rating **	M	Issue No.	81
LM End	0.46	Issue Type +	Ma	Location *	LS
Category	Earthen Levee			GPS Latitude/Longitude	
				Start	End
Item	Slope Stability			38.623101°	38.623101°
				-121.460573°	-121.460573°
DWR ID	DWR_NA0001_01_f_2015_81				
Comment Code					
S2 : Repair the levee slope damaged by foot traffic and prevent access where possible.					
Inspector Comment

View of the landside levee slope damaged by foot traffic. Fall 2016.

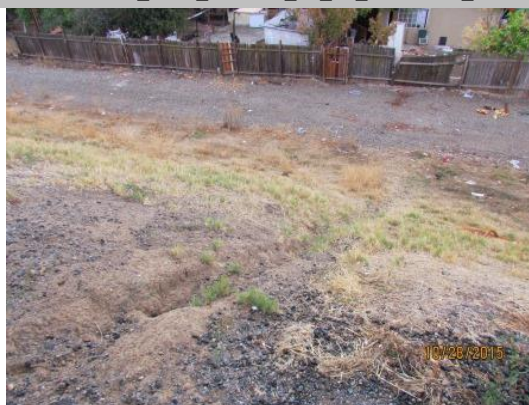
Photo 2 of 2 : SP_2017_NA0001_51_81_20170313_00049.jpg

View of the landside levee slope damaged by foot traffic.

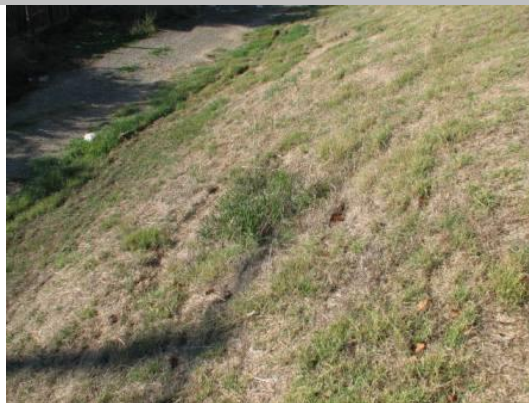
Photo 1 of 2 : SP_2017_NA0001_51_164_20170313_00052.jpg

LM Start	0.48	Rating **	A/W	Issue No.	164
LM End	0.48	Issue Type +	Ma	Location *	LS
Category	Earthen Levee			GPS Latitude/Longitude	
				Start	End
Item	Erosion / Bank Caving			38.623227 °	38.623227 °
				-121.460399 °	-121.460399 °
DWR ID	DWR_NA0001_01_s_2012_164				
Comment Code					
E1 : Note and monitor erosion site.					
Inspector Comment					
4'-5' diameter by 1' deep hole mid-slope on the landside.

11/17/2011 Hole/depression approximately mid-slope.

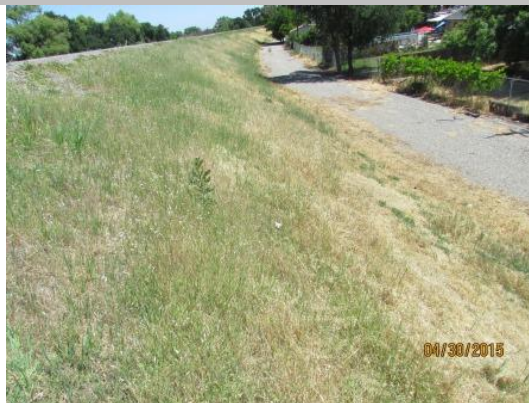
Photo 2 of 2 : SP_2017_NA0001_51_164_20170313_00053.jpg

LM Start	0.48	Rating **	A/W	Issue No.	164 (cont)	
LM End	0.48	Issue Type +	Ma	Location *	LS	
Category	Earthen Levee			GPS Latitude/Longitude		
				Start		End
Item	Erosion / Bank Caving			38.623227 °		38.623227 °
				-121.460399 °		-121.460399 °
DWR ID	DWR_NA0001_01_s_2012_164					
Comment Code						
E1 : Note and monitor erosion site.						
Inspector Comment						
4'-5' diameter by 1' deep hole mid-slope on the landside.

Another view of the depression on the landside levee slope.

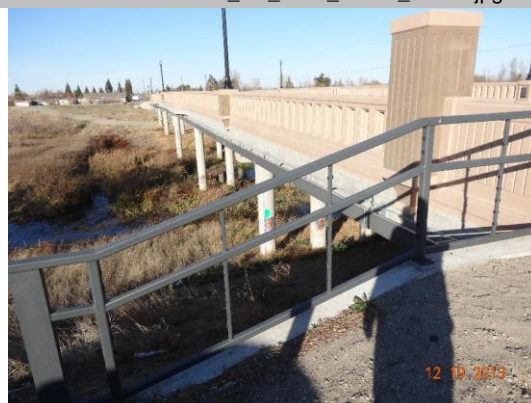
Photo 1 of 3 : UCIP_SP_2017_49930_57042.jpg

FS_ID:49930
DS_ID:24266
EP_NO: 3417
Repair Type: Urgent
Crossing Status: Found
UCIP Comments: 8/11/2016 Markers still missing. LMA representatives, Tim Kerr and Richard Marck, provided permit for 4-inch PG&E gasline to be raised to 200-year water surface elevation. Pipe will be modified on both the right and left bank. Elevation through the levee will need to be modified once pipe is raised through levee. (DWR UCIP - omagana)12/19/2013 no markers visible on waterward or landward side indicating this is a gas line--need to contact owner to determine if this crossing is gas line. (DWR UCIP - omagana)
FIELD_STRUCT_DESC: 4-inch steel gas line through the levee, 1.5 feet below the crown. Corrugated metal (CM) cutoff wall around pipe at the center of levee. Pipe hung along bridge across channel. 4-inch gate valve will be installed on the LS approximately 355 feet from levee crown (near Fairbanks Avenue and Norwood Avenue). (4-inch pipe installed under Permit No. 3417, 1961 - Pacific Gas and Electric Company [PG&E]; 4-inch pipe removed and replaced under Permit 18641, 2011 - PG&E; 4-inch pipe through levee (both right and left bank) raised above the 200-year water surface elevation under Permit No. 18641-1, 2016 - PG&E) [Additional Reference(s): DWR Levee Log, 2002]

View of WS--pipe suspended along downstream face of bridge.

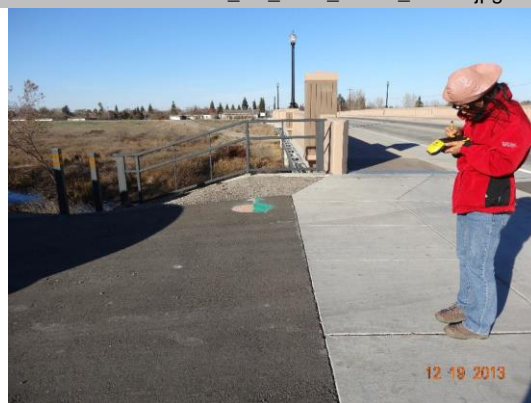
Photo 2 of 3 : UCIP_SP_2017_49930_57041.jpg

Paint on paved levee indicates crossing could be a storm drain.

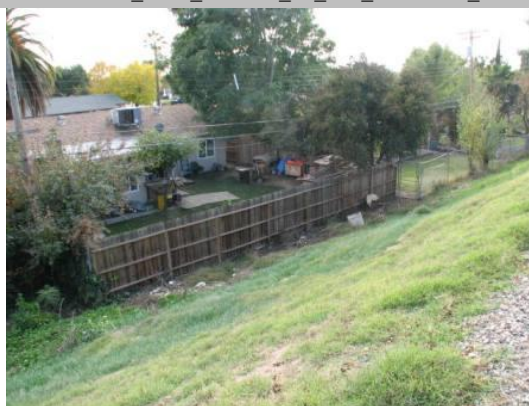
Photo 1 of 1 : SP_2017_NA0001_51_183_20170313_00061.jpg

LM Start	0.77	Rating **	U	Issue No.	183
LM End	0.77	Issue Type +	En	Location *	LS
Category	Earthen Levee			GPS Latitude/Longitude	
				Start	End
Item	Encroachments			38.624016 °	38.624016 °
				-121.455193 °	-121.455193 °
DWR ID	DWR_NA0001_01_s_2012_183				
Comment Code					
FE : Fence					
Inspector Comment					
Dog-eared fence built within 10' of the toe

11/17/2011 Wooden privacy fence.

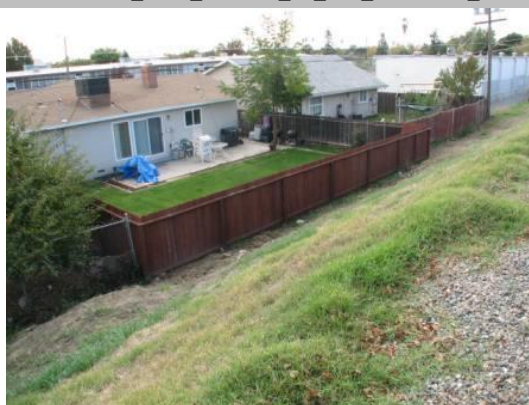
Photo 1 of 1 : SP_2017_NA0001_51_182_20170313_00060.jpg

LM Start	0.95	Rating **	U	Issue No.	182
LM End	0.95	Issue Type +	En	Location *	LS
Category	Earthen Levee			GPS Latitude/Longitude	
				Start	End
Item	Encroachments			38.625072 °	38.625072 °
				-121.452225 °	-121.452225 °
DWR ID	DWR_NA0001_01_s_2012_182				
Comment Code					
FE : Fence					
Inspector Comment					
Dog-eared wooden fence built within 10' of the toe.

11/17/2011 Wooden privacy fence built at the levee toe.

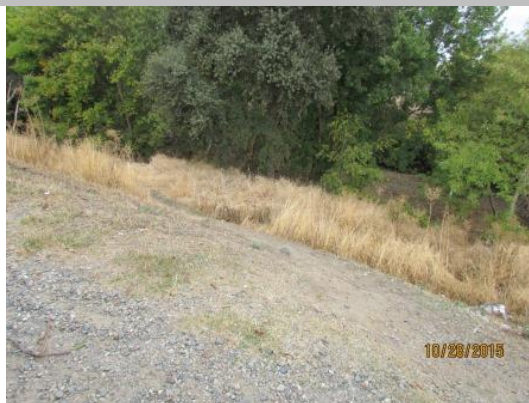
Photo 1 of 1 : SP_2017_NA0001_51_76_20170313_00047.jpg

LM Start	1.05	Rating **	M	Issue No.	76
LM End	1.05	Issue Type +	Ma	Location *	WS
Category	Earthen Levee			GPS Latitude/Longitude	
				Start	End
Item	Slope Stability			38.625069 °	38.625069 °
				-121.450360 °	-121.450360 °
DWR ID	DWR_NA0001_01_f_2015_76				
Comment Code					
S2 : Repair the levee slope damaged by foot traffic and prevent access where possible.					
Inspector Comment

View of the waterside levee slope damaged by foot traffic.

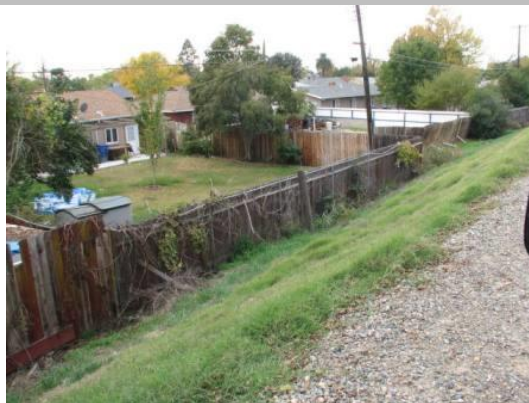
Photo 1 of 1 : SP_2017_NA0001_51_23_20170313_00020.jpg

LM Start	1.15	Rating **	U	Issue No.	23
LM End	1.15	Issue Type +	En	Location *	LS
Category	Earthen Levee			GPS Latitude/Longitude	
				Start	End
Item	Encroachments			38.624871 °	38.624871 °
				-121.448624 °	-121.448624 °
DWR ID	DWR_NA0001_01_s_2012_23				
Comment Code					
FE : Fence					
Inspector Comment					
Dog-eared wooden fence and chain link fence is built against the levee slope.

11/17/2011 Fence built on the levee slope.

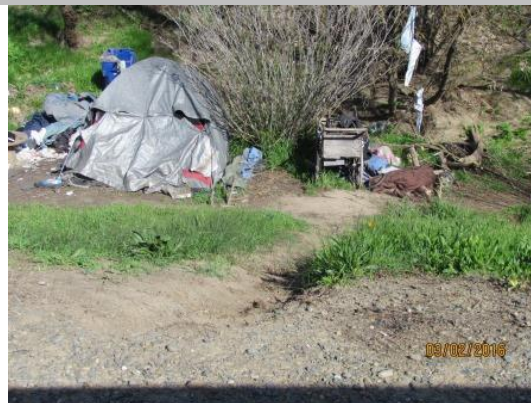
Photo 1 of 1 : SP_2017_NA0001_51_82_20170313_00050.jpg

LM Start	1.15	Rating **	A/W	Issue No.	82
LM End	1.15	Issue Type +	Ma	Location *	WS
Category	Earthen Levee			GPS Latitude/Longitude	
				Start	End
Item	Slope Stability			38.624866 °	38.624866 °
				-121.448555 °	-121.448555 °
DWR ID	DWR_NA0001_01_s _ 2016_82				
Comment Code					
S2 : Repair the levee slope damaged by foot traffic and prevent access where possible.					
Inspector Comment					
Homeless have created foot path.

View of the waterside levee slope erosion.

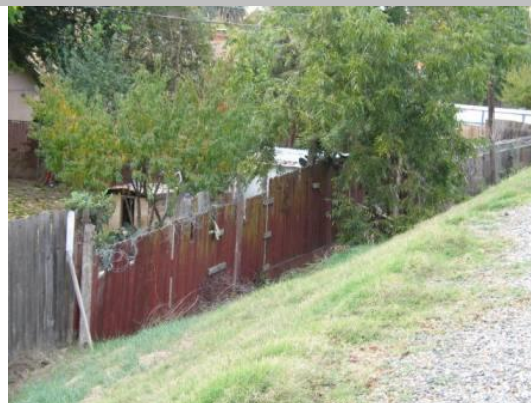
Photo 1 of 1 : SP_2017_NA0001_51_22_20170313_00019.jpg

LM Start	1.15	Rating **	U	Issue No.	22
LM End	1.15	Issue Type +	En	Location *	LS
Category	Earthen Levee			GPS Latitude/Longitude	
				Start	End
Item	Encroachments			38.624879 °	38.624879 °
				-121.448486 °	-121.448486 °
DWR ID	DWR_NA0001_01_s _ 2012_22				
Comment Code					
FE : Fence					
Inspector Comment					
Dog-eared wooden fence is built against the levee slope.

11/17/2011 Wooden privacy fence built at the levee toe.

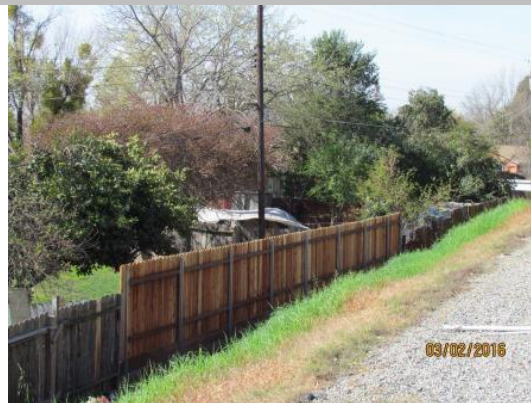
Photo 1 of 1 : SP_2017_NA0001_51_21_20170313_00018.jpg

LM Start	1.17	Rating **	U	Issue No.	21
LM End	1.17	Issue Type +	En	Location *	LS
Category	Earthen Levee			GPS Latitude/Longitude	
				Start	End
Item	Encroachments			38.624906 °	38.624906 °
				-121.448259 °	-121.448259 °
DWR ID	DWR_NA0001_01_s _ 2012_21				
Comment Code					
FE : Fence					
Inspector Comment					
Dog-eared wooden fence is built against the levee slope.

View of the fence at the landside levee toe.

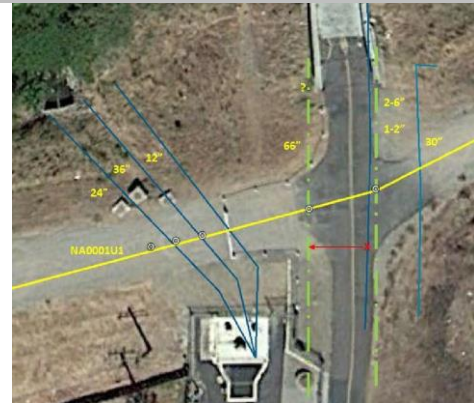
Photo 1 of 1 : UCIP_SP_2017_31178_57059.jpg

LM Start	1.22	Rating **	M	Issue No.	186
LM End	1.22	Issue Type +	En	Location *	LS
Category	Supplemental			GPS Latitude/Longitude	
				Start	End
Item	DWR UCIP Field Study			38.625117 °	38.625117 °
				-121.447318 °	-121.447318 °
DWR ID					
Comment Code					
Inspector Comment					
FS_ID:31178 DS_ID:24248 EP_NO: 14575 Repair Type: Non-Urgent Crossing Status: Not Found UCIP Comments: Crossing is present in the layer provided by the City of Sacramento, however this crossing was not found in the field. Need to determine status of crossing. If crossing is no longer used, owner will need to coordinate with Central Valley Flood Protection Board to comply with Title 23. FIELD_STRUCT_DESC: 30-inch concrete encased steel water main through the levee, 4.5 feet below the crown. Steel cutoff wall around pipe at center of levee. (Permit No. 14575-1988) FS Date: 12/19/2013

Alignment indicated in blue is approximate locations for pipes that cross levee. Alignment information was obtained from the City of Sacramento.

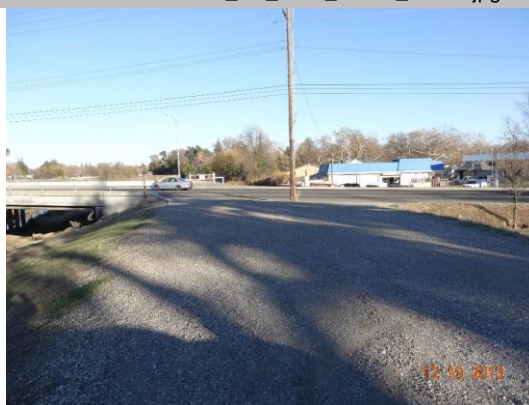
Photo 1 of 3 : UCIP_SP_2017_30085_55489.jpg

LM Start	1.28	Rating **	M	Issue No.	187
LM End	1.28	Issue Type +	En	Location *	LS
Category	Supplemental			GPS Latitude/Longitude	
				Start	End
Item	DWR UCIP Field Study			38.625500 °	38.625500 °
				-121.446390 °	-121.446390 °
DWR ID					
Comment Code					
Inspector Comment					
FS_ID:30085 DS_ID:24576 EP_NO: N/A Repair Type: Non-Urgent Crossing Status: Indicator Found UCIP Comments: Unable to confirm location--will need to coordinate with owner to determine if crossing is still active and determine location. FIELD_STRUCT_DESC: 1 of 3: 16-inch pipe through the levee, 8.0 feet below the crown. Floodgates within the levee across the channel, installed under Permit No. 14480 (1986). FS Date: 12/19/2013

Overview of levee crown at crossing.

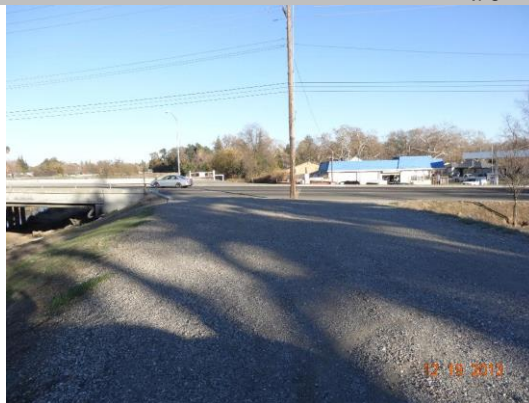
Photo 1 of 3 : UCIP_SP_2017_49932_75855.jpg

Comment Code					
Inspector Comment					
FS_ID:49932 DS_ID:24252 EP_NO: 15152 Repair Type: Urgent Crossing Status: Indicator Found UCIP Comments: 8/11/2016 Markers still missing. Unable to confirm if line will be raised to 200-year water surface elevation at this site. (DWR UCIP - omagana)12/19/2013 Need to confirm if this crossing is gas line. Need to contact owner to determine status of crossing (active or inactive) and to determine last inspection date. Will need copy of letter showing crossings passed inspection. Missing utility markers. (DWR UCIP - omagana) FIELD_STRUCT_DESC: 4-inch steel gas main through the levee, 2.5 feet below the crown. Vent on the waterside (WS) shoulder. Unable to confirm if crossing will be raised to 200-year water surface elevation within Unit 1. (4-inch gas line installed under Permit No. 15152, 1989 - Pacific Gas & Electric Company [PG&E], 4-inch gas line raised above the 200-year water surface elevation under Permit No. 15152-1, 2016 - PG&E) [Additional Reference(s): DWR Levee Log, 2002] FS Date: 8/11/2016

View of levee crown where crossing should be--no markers found.

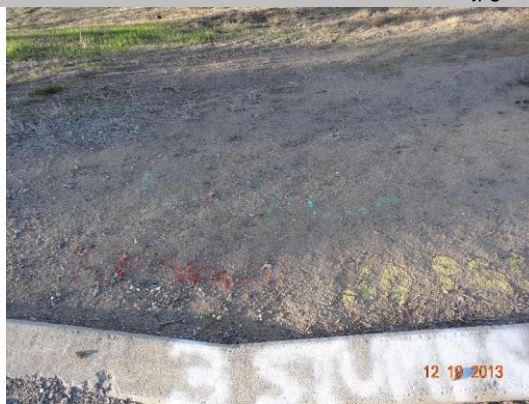
Photo 2 of 3 : UCIP_SP_2017_49932_75856.jpg

Underground service alert (USA) markings found on WS shoulder, photo 1 of 2.

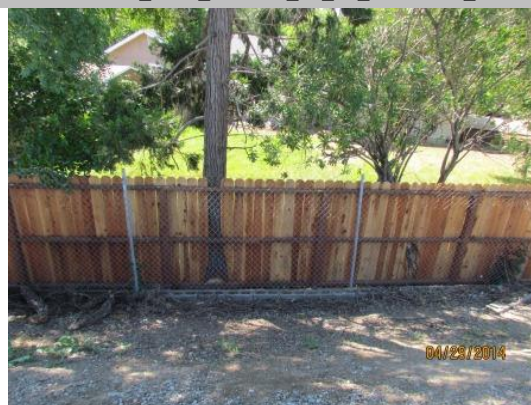
Photo 1 of 1 : SP_2017_NA0001_51_50_20170313_00032.jpg

LM Start	1.35	Rating **	U	Issue No.	50
LM End	1.35	Issue Type +	En	Location *	LS
Category	Earthen Levee			GPS Latitude/Longitude	
				Start	End
Item	Encroachments			38.625982 °	38.625982 °
				-121.445231 °	-121.445231 °
DWR ID	DWR_NA0001_01_s_2014_50				
Comment Code					
FE : Fence					
Inspector Comment

View of the fence at the landside levee toe obstructing visibility and access.

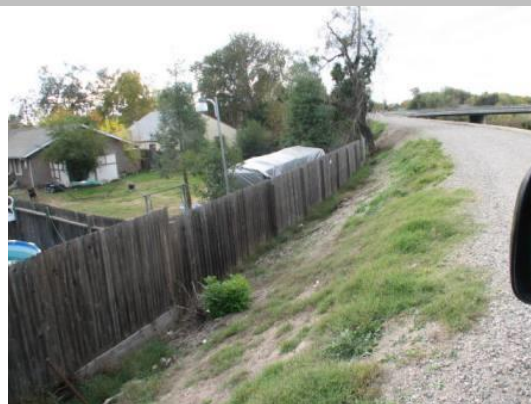
Photo 1 of 1 : SP_2017_NA0001_51_16_20170313_00014.jpg

LM Start	1.36	Rating **	U	Issue No.	16
LM End	1.36	Issue Type +	En	Location *	LS
Category	Earthen Levee			GPS Latitude/Longitude	
				Start	End
Item	Encroachments			38.626000 °	38.626000 °
				-121.444978 °	-121.444978 °
DWR ID	DWR_NA0001_01_s_2012_16				
Comment Code					
FE : Fence					
Inspector Comment					
Wooden privacy fence

11/17/2011 Wooden privacy fence built at the levee toe.

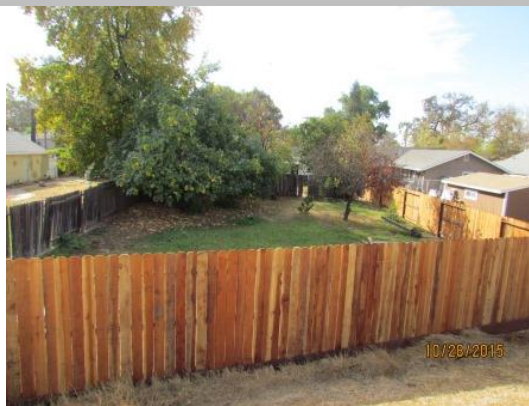
Photo 1 of 1 : SP_2017_NA0001_51_15_20170313_00013.jpg

LM Start	1.37	Rating **	U	Issue No.	15
LM End	1.37	Issue Type +	En	Location *	LS
Category	Earthen Levee			GPS Latitude/Longitude	
				Start	End
Item	Encroachments			38.626048 °	38.626048 °
				-121.444785 °	-121.444785 °
DWR ID	DWR_NA0001_01_s_2012_15				
Comment Code					
FE : Fence					
Inspector Comment					
Wooden privacy fence LS toe.

View of the fence at the landside levee toe.

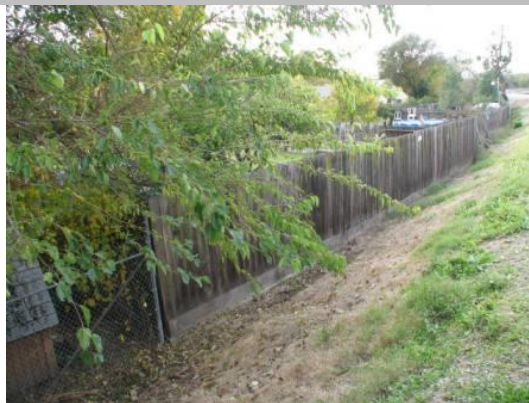
Photo 1 of 1 : SP_2017_NA0001_51_14_20170313_00012.jpg

LM Start	1.38	Rating **	U	Issue No.	14
LM End	1.38	Issue Type +	En	Location *	LS
Category	Earthen Levee			GPS Latitude/Longitude	
				Start	End
Item	Encroachments			38.626085 °	38.626085 °
				-121.444580 °	-121.444580 °
DWR ID	DWR_NA0001_01_s_2012_14				
Comment Code					
FE : Fence					
Inspector Comment					
Wooden privacy fence

11/17/2011 Wooden privacy fence built at the levee toe.

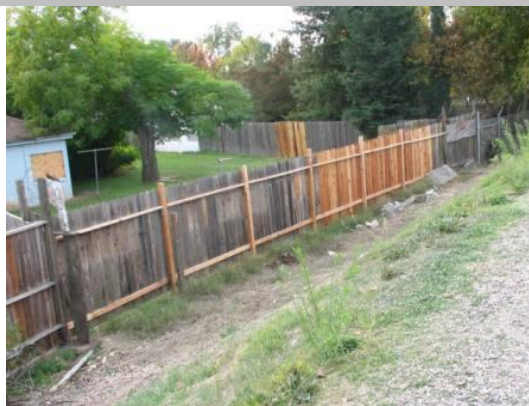
Photo 1 of 1 : SP_2017_NA0001_51_13_20170313_00011.jpg

LM Start	1.40	Rating **	U	Issue No.	13
LM End	1.40	Issue Type +	En	Location *	LS
Category	Earthen Levee			GPS Latitude/Longitude	
				Start	End
Item	Encroachments			38.626155 °	38.626155 °
				-121.444250 °	-121.444250 °
DWR ID	DWR_NA0001_01_s_2012_13				
Comment Code					
FE : Fence					
Inspector Comment					
Wooden fence with barbed wire is built within 10-ft of levee toe. 04/13/2011 Fence has blown over and now partially rests on the levee. Fall insp 2011 fence has been rebuilt in same location, within 10' of levee toe.

11/17/2011 New wooden privacy fence built within 15' of the levee toe.

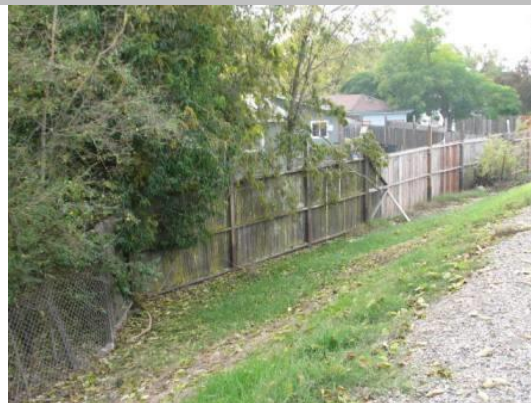
Photo 1 of 1 : SP_2017_NA0001_51_12_20170313_00010.jpg

LM Start	1.41	Rating **	U	Issue No.	12
LM End	1.41	Issue Type +	En	Location *	LS
Category	Earthen Levee			GPS Latitude/Longitude	
				Start	End
Item	Encroachments			38.626212 °	38.626212 °
				-121.444082 °	-121.444082 °
DWR ID	DWR_NA0001_01_s _ 2012_12				
Comment Code					
FE : Fence					
Inspector Comment					
Dog-eared wooden fence is built near the levee slope.

11/17/2011 Wooden privacy fence built within 15' of the levee toe.

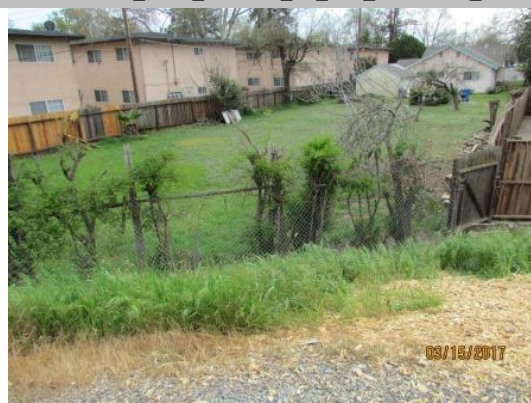
Photo 1 of 2 : SP_2017_NA0001_51_177_20170327_00095.jpg

LM Start	1.42	Rating **	M	Issue No.	177
LM End	1.42	Issue Type +	En	Location *	LS
Category	Earthen Levee			GPS Latitude/Longitude	
				Start	End
Item	Vegetation			38.626388 °	38.626388 °
				-121.443910 °	-121.443910 °
DWR ID	DWR_NA0001_01_s _ 2012_177				
Comment Code					
V6 : Landscaping					
Inspector Comment

Another view of the vegetation at levee toe. Spring 2017.

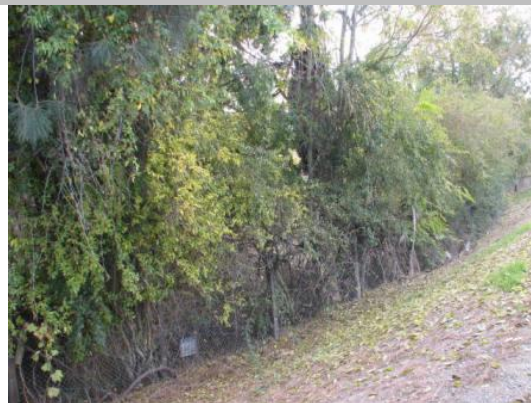
Photo 2 of 2 : SP_2017_NA0001_51_177_20170313_00058.jpg

11/17/2011 Thick vegetation at the levee toe.

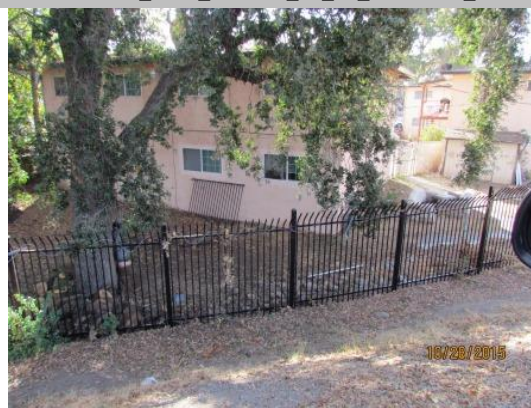
Photo 1 of 1 : SP_2017_NA0001_51_70_20170313_00045.jpg

LM Start	1.44	Rating **	U	Issue No.	70
LM End	1.44	Issue Type +	En	Location *	LS
Category	Earthen Levee			GPS Latitude/Longitude	
				Start	End
Item	Encroachments			38.626589 °	38.626589 °
				-121.443640 °	-121.443640 °
DWR ID	DWR_NA0001_01_f_2015_70				
Comment Code					
FE : Fence					
Inspector Comment					
Rought iron fence at LS toe blocks access.

View of the fence at the landside levee toe.

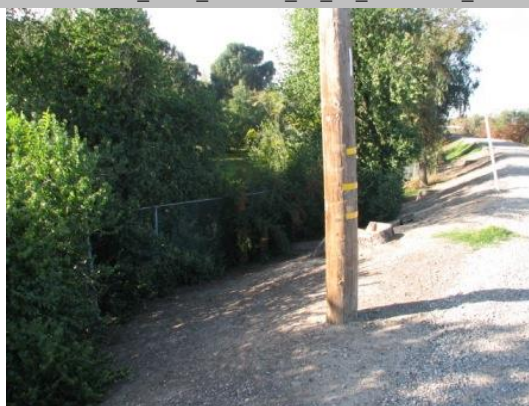
Photo 1 of 1 : SP_2017_NA0001_51_35_20170313_00027.jpg

LM Start	1.53	Rating **	M	Issue No.	35
LM End	1.53	Issue Type +	En	Location *	LS
Category	Earthen Levee			GPS Latitude/Longitude	
				Start	End
Item	Vegetation			38.627255 °	38.627255 °
				-121.442402 °	-121.442402 °
DWR ID	DWR_NA0001_01_s_2012_35				
Comment Code					
V6 : Landscaping					
Inspector Comment					
Bushes and trees along chain link fence block access and visibility.

Fall 2009 photo:Vegetation obstructing visibility near levee slope.

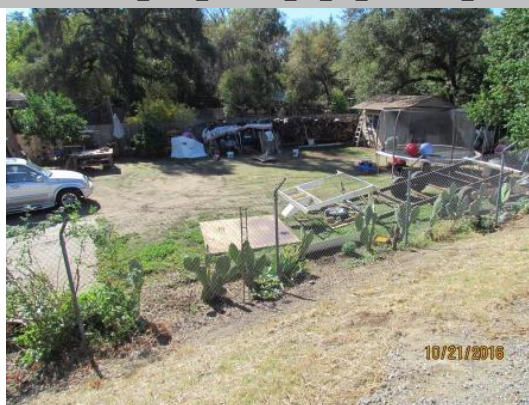
Photo 1 of 1 : SP_2017_NA0001_51_68_20170313_00044.jpg

LM Start	1.54	Rating **	M	Issue No.	68
LM End	1.54	Issue Type +	En	Location *	LS
Category	Earthen Levee			GPS Latitude/Longitude	
				Start	End
Item	Vegetation			38.627283 °	38.627283 °
				-121.442180 °	-121.442180 °
DWR ID	DWR_NA0001_01_f_2015_68				
Comment Code					
V6 : Landscaping					
Inspector Comment					
Cactus planted along LS toe.

View of the landscaping at the landside levee toe.

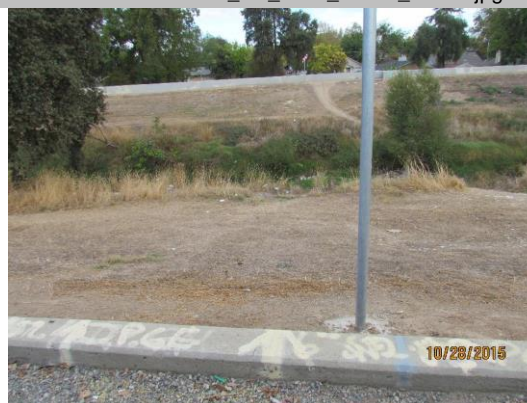
Photo 1 of 3 : UCIP_SP_2017_46793_74731.jpg

LM Start	1.57	Rating **	M	Issue No.	190
LM End	1.57	Issue Type +	En	Location *	LS
Category	Supplemental			GPS Latitude/Longitude	
				Start	End
Item	DWR UCIP Field Study			38.627277 °	38.627277 °
				-121.441650 °	-121.441650 °
DWR ID					
Comment Code					
Inspector Comment					
FS_ID:46793 DS_ID:24573 EP_NO: N/A Repair Type: Non-Urgent Crossing Status: Indicator Found UCIP Comments: 11/12/15 Markers have been installed on both levees--confirmed during DWR Fall Inspection. Need to coordinate with PG&E to determine permit for this crossing.12/19/13 No markers visible indicating crossing through levee. PG&E line. Need to coordinate with owner. Permit? FIELD_STRUCT_DESC: 2 of 2: 6-inch pipe through the levee, at unknown depth and goes under the channel. FS Date: 11/12/2015 1:52:00 PM

Markers installed on both levees in 2015.

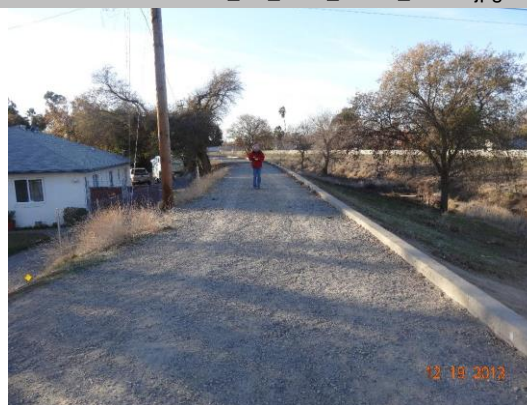
Photo 2 of 3 : UCIP_SP_2017_46793_57072.jpg

Overview of area near crossing. Inspector is standing where crossing goes through levee.

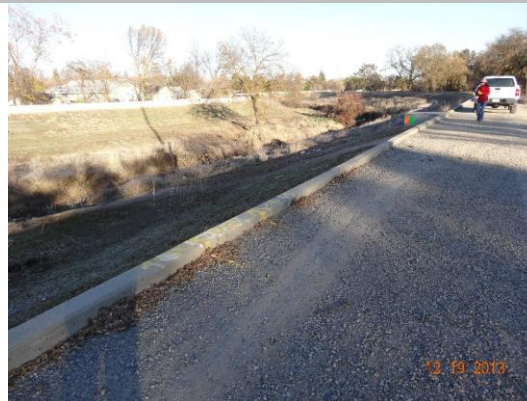
Photo 3 of 3 : UCIP_SP_2017_46793_57071.jpg

LM Start	1.57	Rating **	M	Issue No.	190 (cont)	
LM End	1.57	Issue Type +	En	Location *	LS	
Category	Supplemental			GPS Latitude/Longitude		
				Start	End	
Item	DWR UCIP Field Study			38.627277 °	38.627277 °	
				-121.441650 °	-121.441650 °	
DWR ID						
Comment Code						
Inspector Comment						
FS_ID:46793 DS_ID:24573 EP_NO: N/A Repair Type: Non-Urgent Crossing Status: Indicator Found UCIP Comments: 11/12/15 Markers have been installed on both levees--confirmed during DWR Fall Inspection. Need to coordinate with PG&E to determine permit for this crossing.12/19/13 No markers visible indicating crossing through levee. PG&E line. Need to coordinate with owner. Permit? FIELD_STRUCT_DESC: 2 of 2: 6-inch pipe through the levee, at unknown depth and goes under the channel. FS Date: 11/12/2015 1:52:00 PM

View of waterward side.

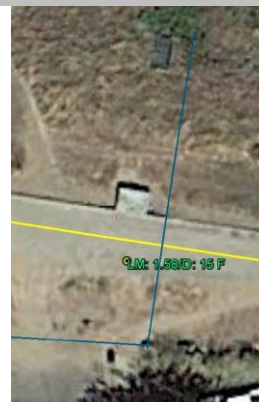
Photo 1 of 3 : UCIP_SP_2017_31182_57075.jpg

LM Start	1.58	Rating **	M	Issue No.	191
LM End	1.58	Issue Type +	En	Location *	LS
Category	Supplemental			GPS Latitude/Longitude	
				Start	End
Item	DWR UCIP Field Study			38.627241 °	38.627241 °
				-121.441465 °	-121.441465 °
DWR ID					
Comment Code					
Inspector Comment					
FS_ID:31182 DS_ID:24255 EP_NO: N/A Repair Type: Non-Urgent Crossing Status: Found UCIP Comments: 1/29/14 1/29/14 approximate alignment of crossings was provided by the City of Sacramento for known crossings through levee. Unable to confirm last inspection. Also City records indicate 24-inch CMP not 15-inch--need to clarify with owner. Crossing is operational. FIELD_STRUCT_DESC: 15-inch pipe through the levee, 8.5 feet below the crown. Flap gate on the waterside (WS) end. FS Date: 12/19/2013

Alignment in blue is an estimate of pipe alignment provided by the City of Sacramento. The symbol at LM 1.58 is field confirmed location.

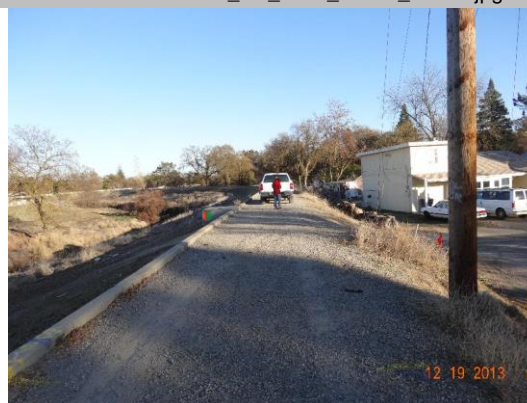
Photo 2 of 3 : UCIP_SP_2017_31182_57076.jpg

LM Start	1.58	Rating **	M	Issue No.	191 (cont)
LM End	1.58	Issue Type +	En	Location *	LS
Category	Supplemental			GPS Latitude/Longitude	
				Start	End
Item	DWR UCIP Field Study			38.627241 °	38.627241 °
				-121.441465 °	-121.441465 °
DWR ID					
Comment Code					
Inspector Comment					
FS_ID:31182 DS_ID:24255 EP_NO: N/A Repair Type: Non-Urgent Crossing Status: Found UCIP Comments: 1/29/14 1/29/14 approximate alignment of crossings was provided by the City of Sacramento for known crossings through levee. Unable to confirm last inspection. Also City records indicate 24-inch CMP not 15-inch--need to clarify with owner. Crossing is operational. FIELD_STRUCT_DESC: 15-inch pipe through the levee, 8.5 feet below the crown. Flap gate on the waterside (WS) end. FS Date: 12/19/2013

Overview of levee at crossing.

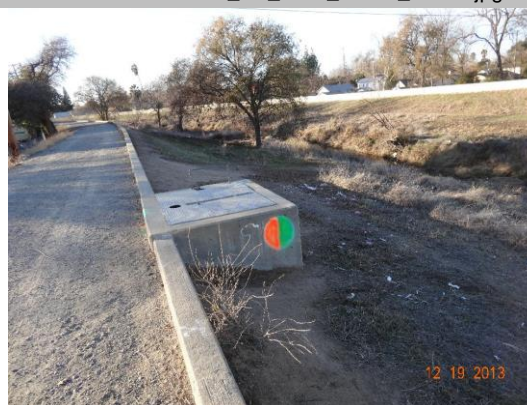
Photo 3 of 3 : UCIP_SP_2017_31182_57077.jpg

View of concrete vault located on waterward apex.

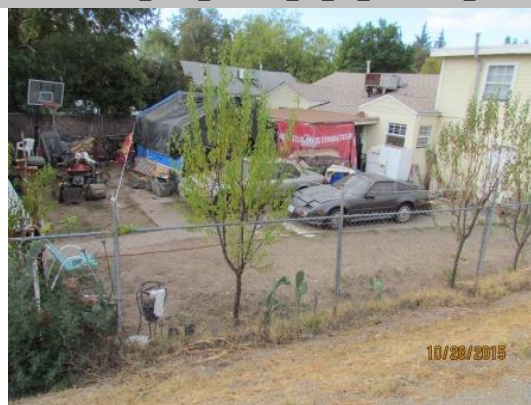
Photo 1 of 1 : SP_2017_NA0001_51_67_20170313_00043.jpg

LM Start	1.60	Rating **	M	Issue No.	67
LM End	1.60	Issue Type +	En	Location *	LS
Category	Earthen Levee			GPS Latitude/Longitude	
				Start	End
Item	Encroachments			38.627207 °	38.627207 °
				-121.441104 °	-121.441104 °
DWR ID	DWR_NA0001_01_f_2015_67				
Comment Code					
FE : Fence					
Inspector Comment					
Fence at landside levee toe. 6 fruit trees and various cactus plants at LS toe.

View of the fence and landscaping at the landside levee toe.

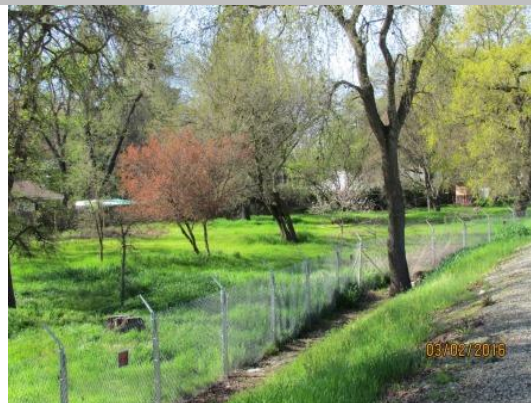
Photo 1 of 1 : SP_2017_NA0001_51_66_20170313_00042.jpg

LM Start	1.61	Rating **	M	Issue No.	66
LM End	1.68	Issue Type +	En	Location *	LS
Category	Earthen Levee			GPS Latitude/Longitude	
				Start	End
Item	Encroachments			38.627195 °	38.627500 °
				-121.440974 °	-121.439766 °
DWR ID	DWR_NA0001_01_f_2015_66				
Comment Code					
FE : Fence					
Inspector Comment					
Fence at landside levee toe.

View of the fence at the landside levee toe.

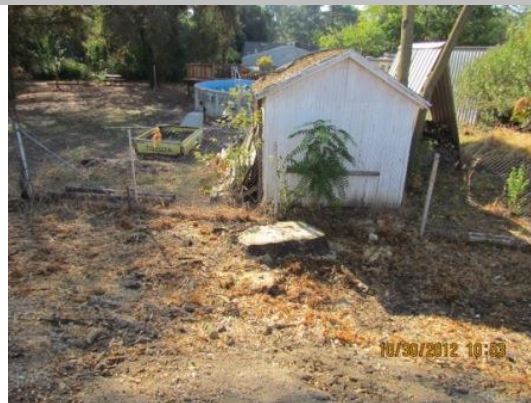
Photo 1 of 1 : SP_2017_NA0001_51_31_20170313_00025.jpg

LM Start	1.61	Rating **	N	Issue No.	31
LM End	1.61	Issue Type +	Ma	Location *	LS
Category	Earthen Levee			GPS Latitude/Longitude	
				Start	End
Item	Trim / Thin Trees			38.627191 °	38.627191 °
				-121.440861 °	-121.440861 °
DWR ID	DWR_NA0001_01_f_2012_31				
Comment Code					
T5 : Tree stumps.					
Inspector Comment

View of large tree stump at levee toe.

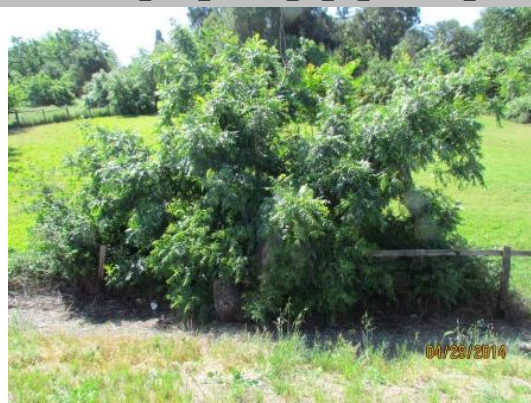
Photo 1 of 1 : SP_2017_NA0001_51_48_20170313_00031.jpg

LM Start	1.69	Rating **	M	Issue No.	48
LM End	1.69	Issue Type +	Ma	Location *	LS
Category	Earthen Levee			GPS Latitude/Longitude	
				Start	End
Item	Vegetation			38.627594 °	38.627594 °
				-121.439540 °	-121.439540 °
DWR ID	DWR_NA0001_01_s_2014_48				
Comment Code					
V2 : Remove the wild growth other than native grasses from the levee slopes.					
Inspector Comment					
Tree obstructing visibility and access.

View of the overgrown tree at the landside levee toe.

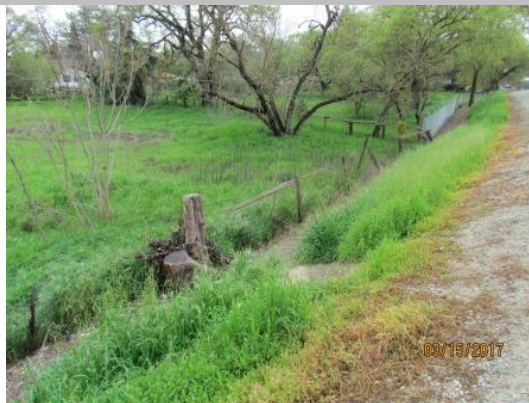
Photo 1 of 1 : SP_2017_NA0001_51_74_20170327_00093.jpg

LM Start	1.69	Rating **	N	Issue No.	74
LM End	1.69	Issue Type +	Ma	Location *	LS
Category	Earthen Levee			GPS Latitude/Longitude	
				Start	End
Item	Trim / Thin Trees			38.627607 °	38.627607 °
				-121.439545 °	-121.439545 °
DWR ID	DWR_NA0001_01_s_2017_74				
Comment Code					
T5 : Tree stumps.					
Inspector Comment					
24 inch large tree stump at levee toe.

View of the tree stump at the levee toe.

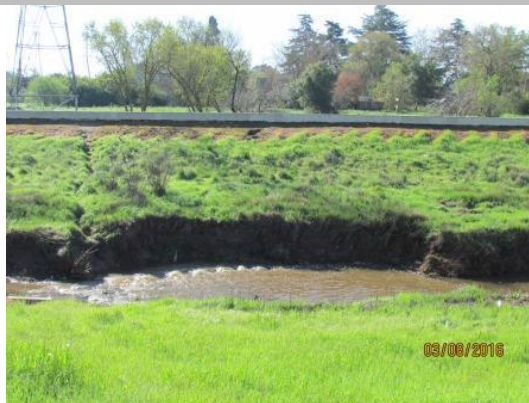
Photo 1 of 1 : SP_2017_NA0001_51_84_20170313_00051.jpg

LM Start	1.74	Rating **	M	Issue No.	84
LM End	1.74	Issue Type +	Ma	Location *	WS
Category	Rivers, Channels & Designated Floodways			GPS Latitude/Longitude	
				Start	End
Item	Erosion / Bank Caving			38.627882 °	38.627882 °
				-121.438602 °	-121.438602 °
DWR ID	DWR_NA0001_01_s_2017_84				
Comment Code					
Inspector Comment					
The LMA is making plans to repair this site soon. Erosion has progressed a little bit as of Spring 2017.

View of the erosion on the waterside levee berm.

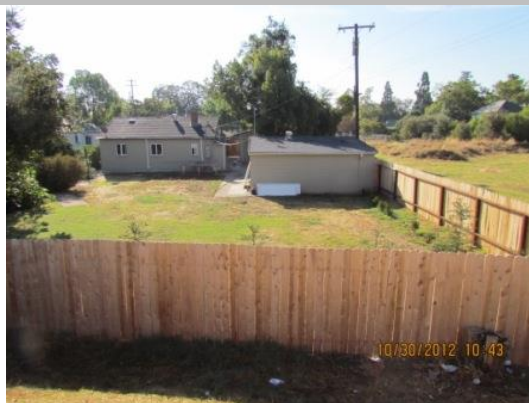
Photo 1 of 1 : SP_2017_NA0001_51_10_20170313_00009.jpg

LM Start	1.79	Rating **	U	Issue No.	10
LM End	1.79	Issue Type +	En	Location *	LS
Category	Earthen Levee			GPS Latitude/Longitude	
				Start	End
Item	Encroachments			38.627948 °	38.627948 °
				-121.437682 °	-121.437682 °
DWR ID	DWR_NA0001_01_f_2012_10				
Comment Code					
FE : Fence					
Inspector Comment					
Wooden fence constructed at LS levee toe.

View of new fence constructed at levee toe and 7 redwood trees planted behind fence within easement.

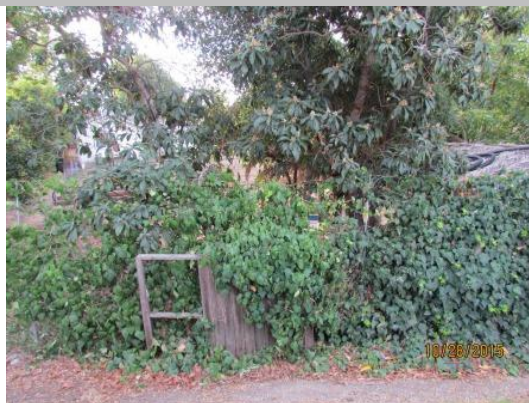
Photo 1 of 1 : SP_2017_NA0001_51_170_20170313_00056.jpg

LM Start	1.81	Rating **	U	Issue No.	170
LM End	1.81	Issue Type +	En	Location *	LS
Category	Earthen Levee			GPS Latitude/Longitude	
				Start	End
Item	Vegetation			38.627934 °	38.627934 °
				-121.437423 °	-121.437423 °
DWR ID	DWR_NA0001_01_s_2012_170				
Comment Code					
V6 : Landscaping					
Inspector Comment					
Growth on old wooden fence, which has since been replaced by a chainlink fence is obstructive.

View of the landscaping at the landside levee toe.

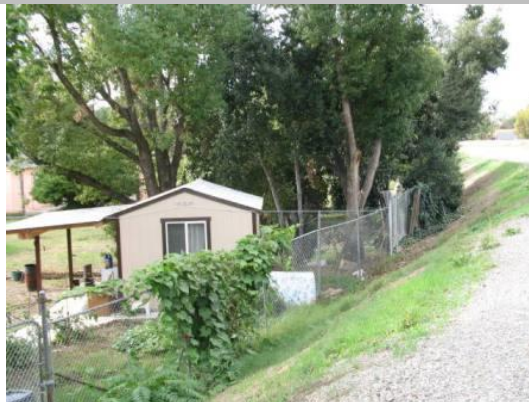
Photo 1 of 1 : SP_2017_NA0001_51_169_20170313_00055.jpg

LM Start	1.82	Rating **	U	Issue No.	169
LM End	1.82	Issue Type +	En	Location *	LS
Category	Earthen Levee			GPS Latitude/Longitude	
				Start	End
Item	Encroachments			38.627922 °	38.627922 °
				-121.437296 °	-121.437296 °
DWR ID	DWR_NA0001_01_s_2012_169				
Comment Code					
BU : Building					
Inspector Comment					
Shed on concrete pad within 10' of the levee toe.

11/17/2011 Wooden shed on concrete pad built within 15' of levee toe.

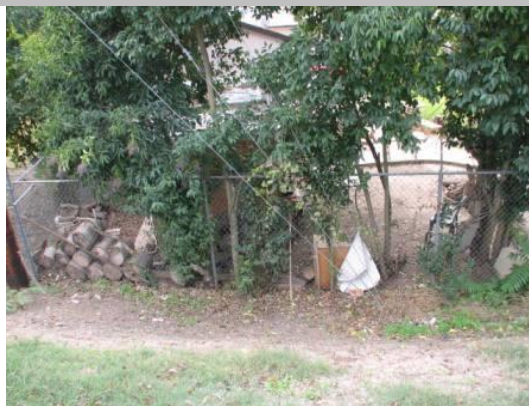
Photo 1 of 1 : SP_2017_NA0001_51_33_20170313_00026.jpg

LM Start	1.83	Rating **	U	Issue No.	33
LM End	1.83	Issue Type +	En	Location *	LS
Category	Earthen Levee			GPS Latitude/Longitude	
				Start	End
Item	Encroachments			38.627897 °	38.627897 °
				-121.437073 °	-121.437073 °
DWR ID	DWR_NA0001_01_s_2012_33				
Comment Code					
BU : Building					
Inspector Comment					
Wooden animal pen is built against levee slope.

11/17/2011 Wooden structure is built within 15' of the levee toe.

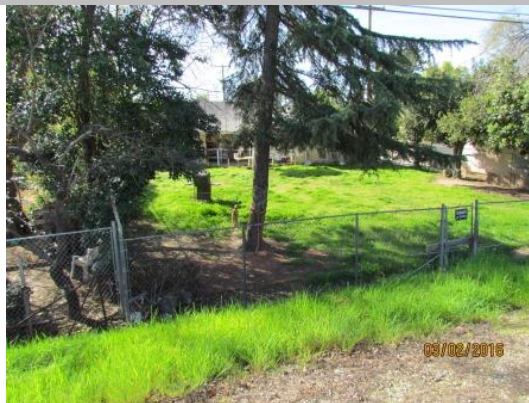
Photo 1 of 1 : SP_2017_NA0001_51_63_20170313_00041.jpg

LM Start	1.84	Rating **	M	Issue No.	63
LM End	1.84	Issue Type +	En	Location *	LS
Category	Earthen Levee			GPS Latitude/Longitude	
				Start	End
Item	Encroachments			38.627879 °	38.627879 °
				-121.436889 °	-121.436889 °
DWR ID	DWR_NA0001_01_f_2015_63				
Comment Code					
FE : Fence					
Inspector Comment					
Fence at landside levee toe.

View of the fence at the landside levee toe.

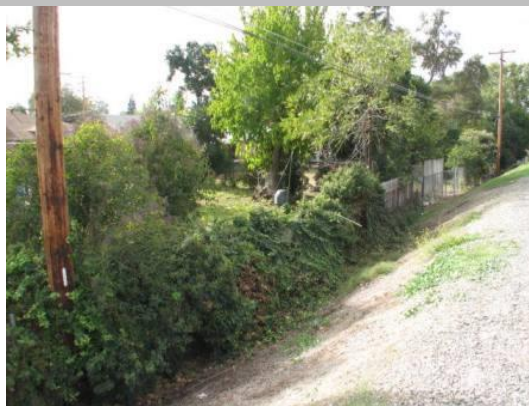
Photo 1 of 1 : SP_2017_NA0001_51_8_20170313_00007.jpg

LM Start	1.85	Rating **	M	Issue No.	8
LM End	1.85	Issue Type +	En	Location *	LS
Category	Earthen Levee			GPS Latitude/Longitude	
				Start	End
Item	Vegetation			38.627889 °	38.627889 °
				-121.436638 °	-121.436638 °
DWR ID	DWR_NA0001_01_s _ 2012_8				
Comment Code					
V6 : Landscaping					
Inspector Comment					
Ivy, trees and other landscaping growing on a privacy fence are obstructing visibility.

11/17/2011 Landscaping vegetation growth on the fence is obstructive.

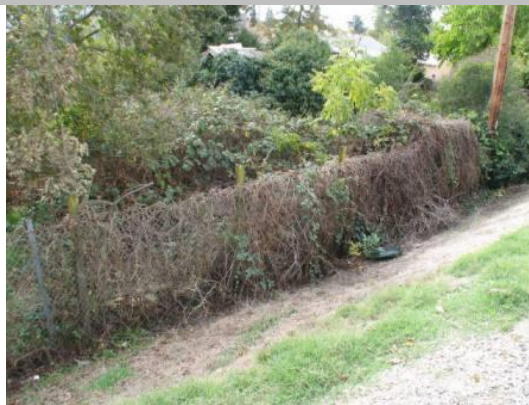
Photo 1 of 1 : SP_2017_NA0001_51_7_20170313_00006.jpg

LM Start	1.86	Rating **	U	Issue No.	7
LM End	1.86	Issue Type +	En	Location *	LS
Category	Earthen Levee			GPS Latitude/Longitude	
				Start	End
Item	Vegetation			38.627889 °	38.627889 °
				-121.436454 °	-121.436454 °
DWR ID	DWR_NA0001_01_s _ 2012_7				
Comment Code					
V6 : Landscaping					
Inspector Comment					
Metal sided shelter, blackberries and cherry trees are obstructive.

11/17/2011 Blackberries growing on fence are obstructive.

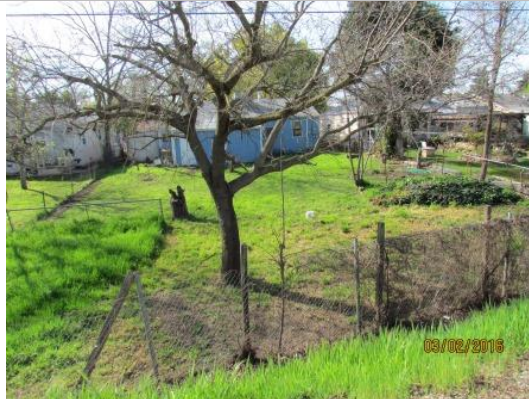
Photo 1 of 1 : SP_2017_NA0001_51_61_20170313_00040.jpg

LM Start	1.86	Rating **	M	Issue No.	61
LM End	1.86	Issue Type +	En	Location *	LS
Category	Earthen Levee			GPS Latitude/Longitude	
				Start	End
Item	Encroachments			38.627885 °	38.627885 °
				-121.436423 °	-121.436423 °
DWR ID	DWR_NA0001_01_f_2015_61				
Comment Code					
FE : Fence					
Inspector Comment					
Fence at landside levee toe.

View of the fence at the landside levee toe.

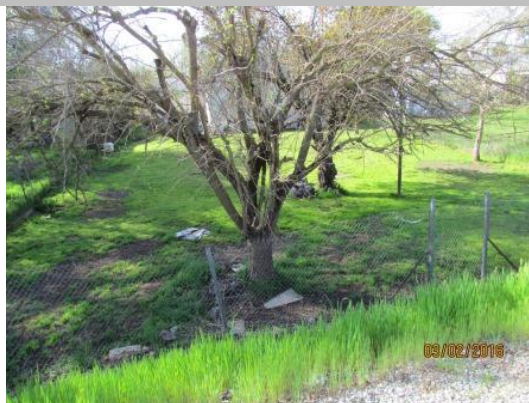
Photo 1 of 1 : SP_2017_NA0001_51_59_20170313_00038.jpg

LM Start	1.88	Rating **	M	Issue No.	59
LM End	1.88	Issue Type +	En	Location *	LS
Category	Earthen Levee			GPS Latitude/Longitude	
				Start	End
Item	Encroachments			38.627871 °	38.627871 °
				-121.436191 °	-121.436191 °
DWR ID	DWR_NA0001_01_f_2015_59				
Comment Code					
FE : Fence					
Inspector Comment					
Fence at landside levee toe.

View of the fence at the landside levee toe.

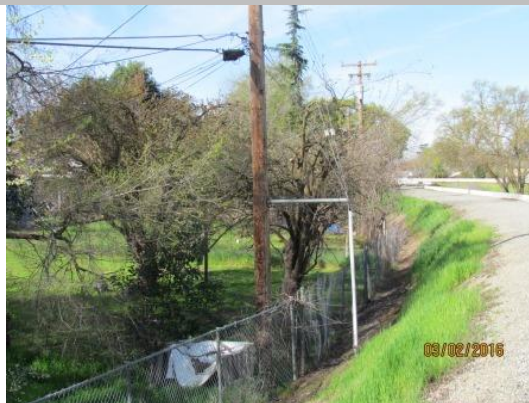
Photo 1 of 1 : SP_2017_NA0001_51_58_20170313_00037.jpg

LM Start	1.88	Rating **	M	Issue No.	58
LM End	1.88	Issue Type +	En	Location *	LS
Category	Earthen Levee			GPS Latitude/Longitude	
				Start	End
Item	Encroachments			38.627860 °	38.627860 °
				-121.436098 °	-121.436098 °
DWR ID	DWR_NA0001_01_f_2015_58				
Comment Code					
PO : Pole					
Inspector Comment					
Pole at the landside levee toe with guy wire penetrating the landside levee slope.

View of the pole at the landside levee toe.

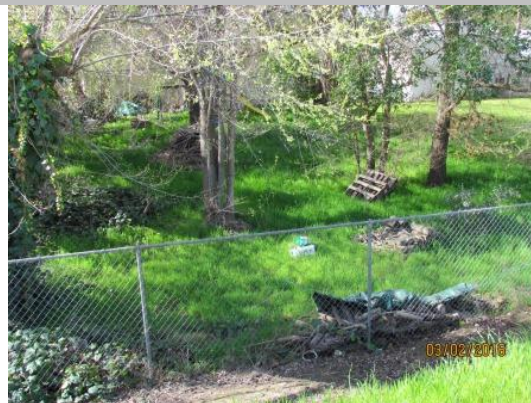
Photo 1 of 1 : SP_2017_NA0001_51_57_20170313_00036.jpg

LM Start	1.89	Rating **	M	Issue No.	57
LM End	1.89	Issue Type +	En	Location *	LS
Category	Earthen Levee			GPS Latitude/Longitude	
				Start	End
Item	Encroachments			38.627837 °	38.627837 °
				-121.435973 °	-121.435973 °
DWR ID	DWR_NA0001_01_f_2015_57				
Comment Code					
FE : Fence					
Inspector Comment					
Fence at landside levee toe.

View of the fence at the landside levee toe.

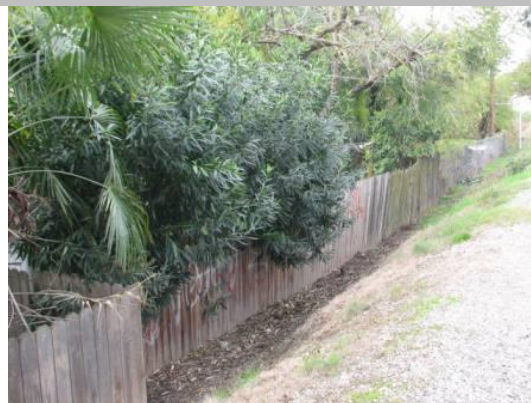
Photo 1 of 1 : SP_2017_NA0001_51_6_20170313_00005.jpg

LM Start	1.90	Rating **	U	Issue No.	6
LM End	1.90	Issue Type +	En	Location *	LS
Category	Earthen Levee			GPS Latitude/Longitude	
				Start	End
Item	Encroachments			38.627725 °	38.627725 °
				-121.435715 °	-121.435715 °
DWR ID	DWR_NA0001_01_s_2012_6				
Comment Code					
FE : Fence					
Inspector Comment					
Dog-eared wooden fence is built within 10-ft of the levee slope.

11/17/2011 Wooden privacy fence built at the levee toe.

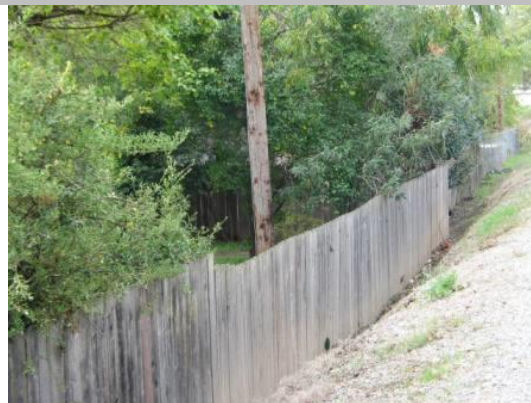
Photo 1 of 1 : SP_2017_NA0001_51_5_20170313_00004.jpg

LM Start	1.91	Rating **	U	Issue No.	5
LM End	1.91	Issue Type +	En	Location *	LS
Category	Earthen Levee			GPS Latitude/Longitude	
				Start	End
Item	Encroachments			38.627680 °	38.627680 °
				-121.435555 °	-121.435555 °
DWR ID	DWR_NA0001_01_s_2012_5				
Comment Code					
FE : Fence					
Inspector Comment					
Dog-eared wooden fence is built against the levee slope.

11/17/2011 Wooden privacy fence built at the levee toe.

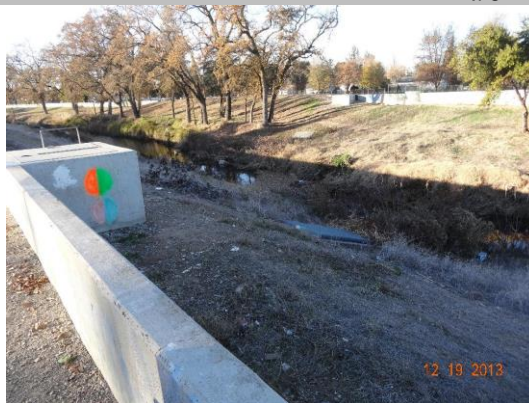
Photo 1 of 3 : UCIP_SP_2017_41549_57087.jpg

LM Start	1.95	Rating **	M	Issue No.	192
LM End	1.95	Issue Type +	En	Location *	LS
Category	Supplemental			GPS Latitude/Longitude	
				Start	End
Item	DWR UCIP Field Study			38.627568 °	38.627568 °
				-121.434815 °	-121.434815 °
DWR ID					
Comment Code					
Inspector Comment					
FS_ID:41549					
DS_ID:24259					
EP_NO: N/A					
Repair Type: Non-Urgent					
Crossing Status: Found					
UCIP Comments: 1/29/14 approximate alignment of crossings was provided by the City of Sacramento for known crossings through levee. Unable to confirm last inspection. Also City records indicate 10-inch not 15-inch--need to clarify with owner. Crossing is operational.					
FIELD_STRUCT_DESC: 15-inch pipe through the levee, 8.5 feet below the crown. Flap gate on the waterside (WS) end.					
FS Date: 12/19/2013

View of waterward side--concrete vault and u-shape concrete headwall with debris screen.

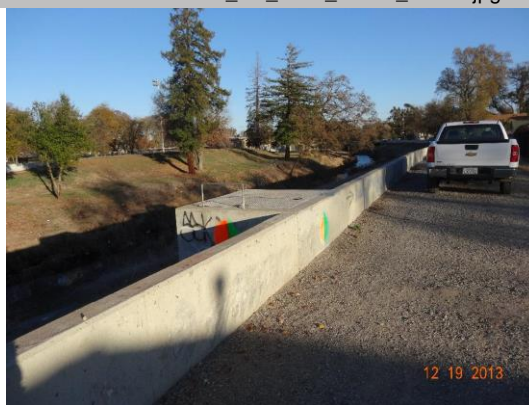
Photo 2 of 3 : UCIP_SP_2017_41549_57086.jpg

View of floodwall along waterward side.

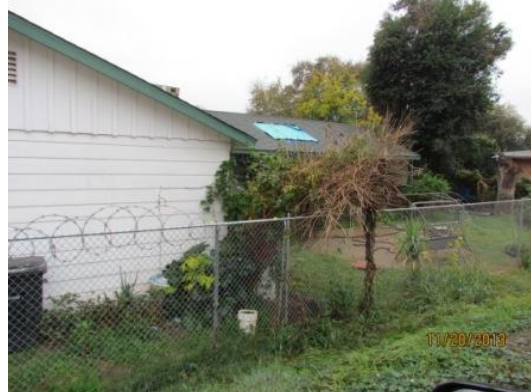
Photo 1 of 1 : SP_2017_NA0001_51_1_20170313_00001.jpg

LM Start	1.99	Rating **	M	Issue No.	1
LM End	1.99	Issue Type +	En	Location *	LS
Category	Earthen Levee			GPS Latitude/Longitude	
				Start	End
Item	Vegetation			38.627318 °	38.627318 °
				-121.434208 °	-121.434208 °
DWR ID	DWR_NA0001_01_s_2012_1				
Comment Code					
V6 : Landscaping					
Inspector Comment					
Vine growing on fence and slope blocks visibility.

View of the fence and landscaping at the landside levee toe.

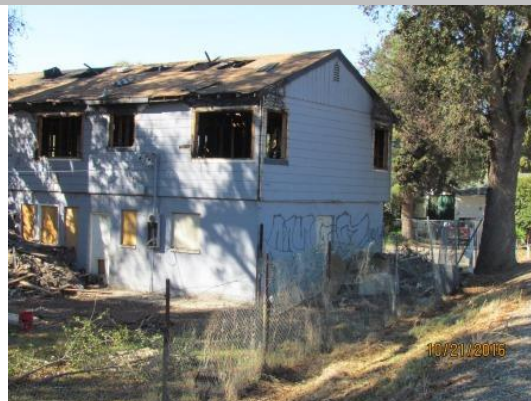
Photo 1 of 1 : SP_2017_NA0001_51_29_20170313_00023.jpg

LM Start	2.02	Rating **	U	Issue No.	29
LM End	2.02	Issue Type +	En	Location *	LS
Category	Earthen Levee			GPS Latitude/Longitude	
				Start	End
Item	Encroachments			38.627292 °	38.627292 °
				-121.433709 °	-121.433709 °
DWR ID	DWR_NA0001_01_s_2012_29				
Comment Code					
BU : Building					
Inspector Comment					
Two-story home foundation is within 10-ft of levee toe. Chain link fence is built on levee toe.

Building foundation is within 15' of the levee toe.

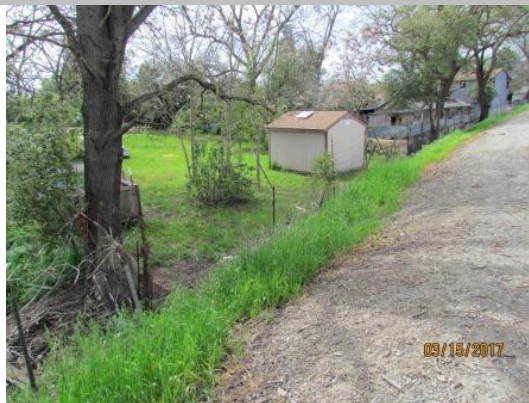
Photo 1 of 1 : SP_2017_NA0001_51_52_20170327_00090.jpg

LM Start	2.05	Rating **	M	Issue No.	52
LM End	2.05	Issue Type +	En	Location *	LS
Category	Earthen Levee			GPS Latitude/Longitude	
				Start	End
Item	Encroachments			38.627254 °	38.627254 °
				-121.433026 °	-121.433026 °
DWR ID	DWR_NA0001_01_f_2015_52				
Comment Code					
FE : Fence					
Inspector Comment					
Fence at the landside levee toe.

View of the fence at the levee toe.

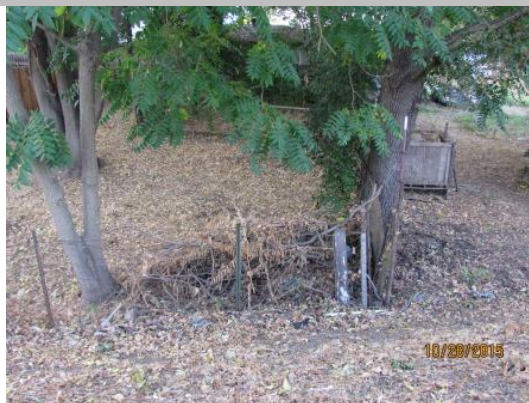
Photo 1 of 1 : SP_2017_NA0001_51_47_20170313_00030.jpg

LM Start	2.06	Rating **	M	Issue No.	47
LM End	2.06	Issue Type +	En	Location *	LS
Category	Earthen Levee			GPS Latitude/Longitude	
				Start	End
Item	Encroachments			38.627255 °	38.627255 °
				-121.432876 °	-121.432876 °
DWR ID	DWR_NA0001_01_f_2015_47				
Comment Code					
PR : Prunings					
Inspector Comment

View of the prunings at the landside levee toe.

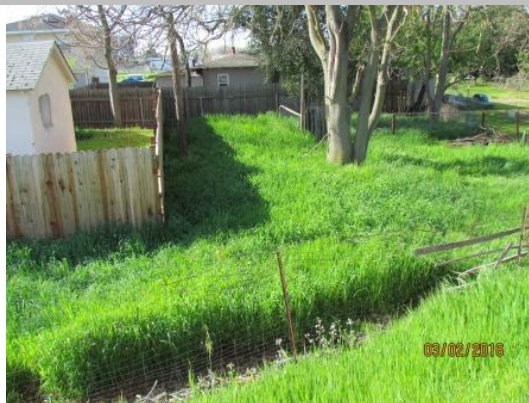
Photo 1 of 1 : SP_2017_NA0001_51_51_20170313_00033.jpg

LM Start	2.06	Rating **	M	Issue No.	51
LM End	2.06	Issue Type +	En	Location *	LS
Category	Earthen Levee			GPS Latitude/Longitude	
				Start	End
Item	Encroachments			38.627251 °	38.627251 °
				-121.432843 °	-121.432843 °
DWR ID	DWR_NA0001_01_f_2015_51				
Comment Code					
FE : Fence					
Inspector Comment					
Fence at landside levee toe.

View of the fence at the landside levee toe.

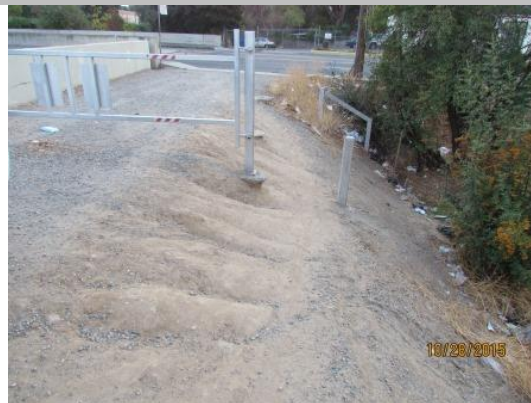
Photo 1 of 1 : SP_2017_NA0001_51_46_20170313_00029.jpg

LM Start	2.07	Rating **	M	Issue No.	46
LM End	2.07	Issue Type +	Ma	Location *	LS
Category	Earthen Levee			GPS Latitude/Longitude	
				Start	End
Item	Slope Stability			38.627246 °	38.627246 °
				-121.432673 °	-121.432673 °
DWR ID	DWR_NA0001_01_f_2015_46				
Comment Code					
S2 : Repair the levee slope damaged by foot traffic and prevent access where possible.					
Inspector Comment					
LMA will fix this site after the levee improvement project is completed.

View of the damaged landside levee slope.

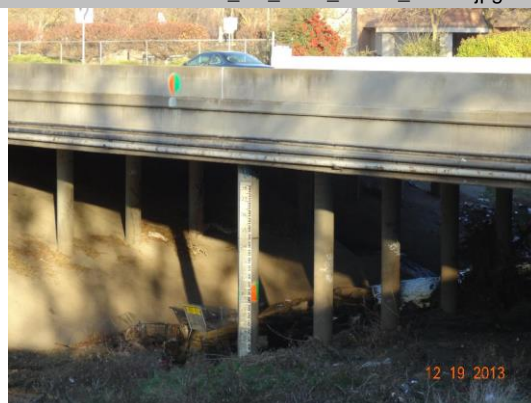
Photo 2 of 3 : UCIP_SP_2017_31185_57090.jpg

LM Start	2.08	Rating **	M	Issue No.	193 (cont)	
LM End	2.08	Issue Type +	En	Location *	LS	
Category	Supplemental			GPS Latitude/Longitude		
				Start		End
Item	DWR UCIP Field Study			38.627239 °		38.627239 °
				-121.432501 °		-121.432501 °
DWR ID						
Comment Code						
Inspector Comment						
FS_ID:31185 DS_ID:24420 EP_NO: 13044 Repair Type: Non-Urgent Crossing Status: Indicator Found UCIP Comments: Orange/Green symbol for flood structure found on floodwall. No crossing found. Need to determine if crossing is in use. This crossing is not shown in the City of Sacramento's sewer drain mains or water mains. Need to contact owner to determine if crossing is still in use. FIELD_STRUCT_DESC: 12-inch steel water main through the levee, 4.0 feet below the crown. (Permit No. 13044-1981) FS Date: 12/19/2013

Markers visible of crossing on bridge.
